Aortic Rupture Following an EVAR Secondary to Graft Erosion

Igor Banzic^{1,2}, Mario Lachat¹, Thomas Pfammatter¹, Dieter Mayer¹, Vladimir Cvetic², Zoran Rancic¹

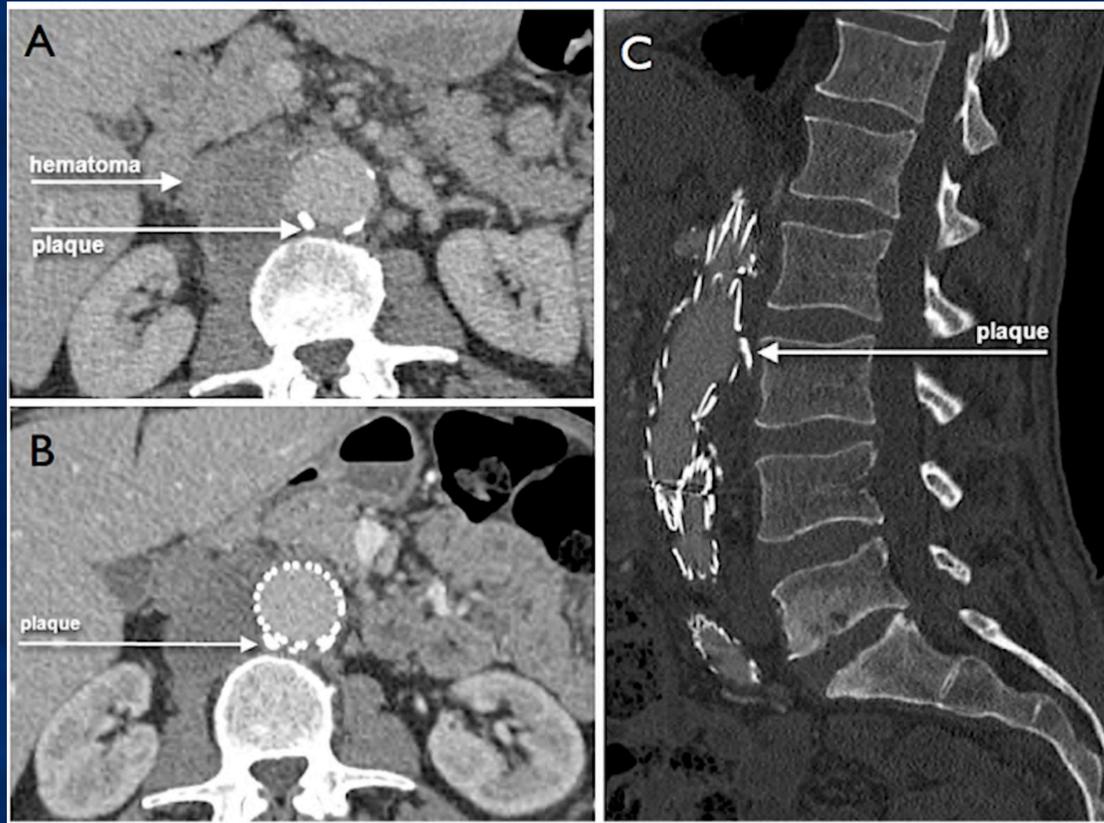
Figure 1.

- A 68-year-old male patient was presented with retroperitoneal bleeding due to aortic plaque rupture (Fig. 1A). This unusual aortic syndrome was treated with endovascular graft placement. A Zenith bifurcated main body graft (TFFB-32-82-ZT) was used; an Excluder (PXL 161207) was used for the right limb of the graft, and a Zenith (TFLE 12-73-ZT) was used for the left limb of the graft. The case was done urgently and a mix-and-match approach was required due to endografts availability at the moment. Other than plaque that had been present on the previous CT, no unusual findings were revealed on the one-year CT control (Fig. 1).

- This case report presents a unique complication in endograft placement for an unusual aortic syndrome, ruptured aortic plaque. It is very suspicious that the type 3 endoleak was secondary to the sharp aortic plaque. In the presented case, plaque was evident in the same place in all of the CT controls. The plaque was responsible for the aortic rupture and was in close proximity to the endograft (Fig. 1A).

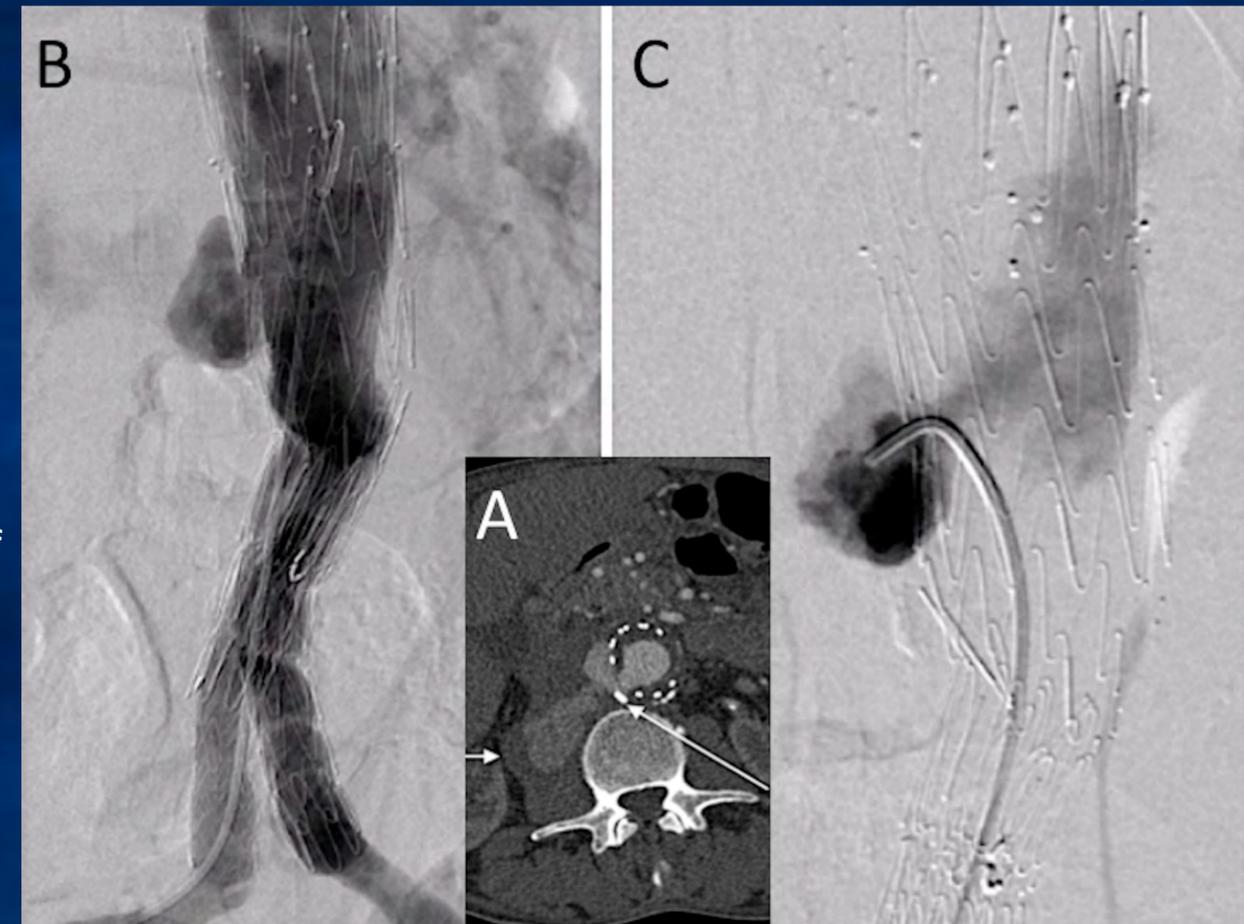
Figure 2.

- Two years after the EVAR, the patient was re-admitted with a seven-day history of severe abdominal pain. A CT angiography showed a large retroperitoneal hematoma, contrast extravasation, and a type 3 endoleak. Since the first procedure was performed the patient did not experience any trauma or prior intravascular procedures, which could be related to aortic or graft injury. The patient was treated immediately with an aortic infrarenal cuff (Jotec) that was placed percutaneously through the left groin (AFC) under local anesthesia. Before the cuff was placed, following control angiography a hole in the graft became evident. Because it was possible to insert an angiographic catheter through the hole in the graft (Fig. 2), the hole diameter was at least 2 mm.

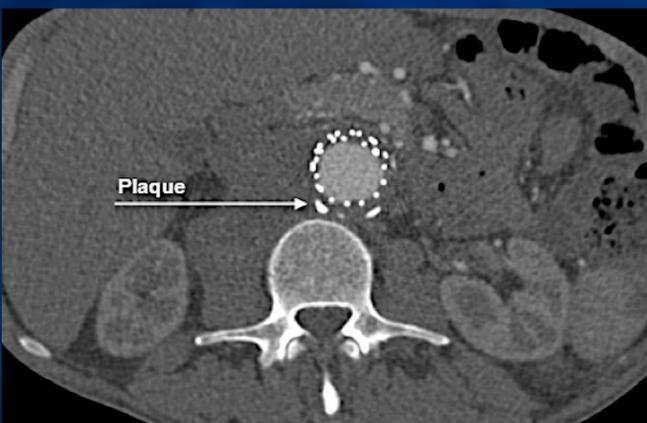
Figure 3.

- Six months post-procedural CT imaging showed adequate cuff positioning with no endoleak or contrast extravasation (Fig. 3). There were no systemic or CT signs of infection
